**PROGRAM FOR EXPERIMENTAL INVESTIGATION OF FAILURE
PROGNOSIS OF HELICOPTER GEARBOXES**

**Northrop Research and Technology Center
3401 West Broadway
Hawthorne, Calif. 90250**

August 1976

Final Report

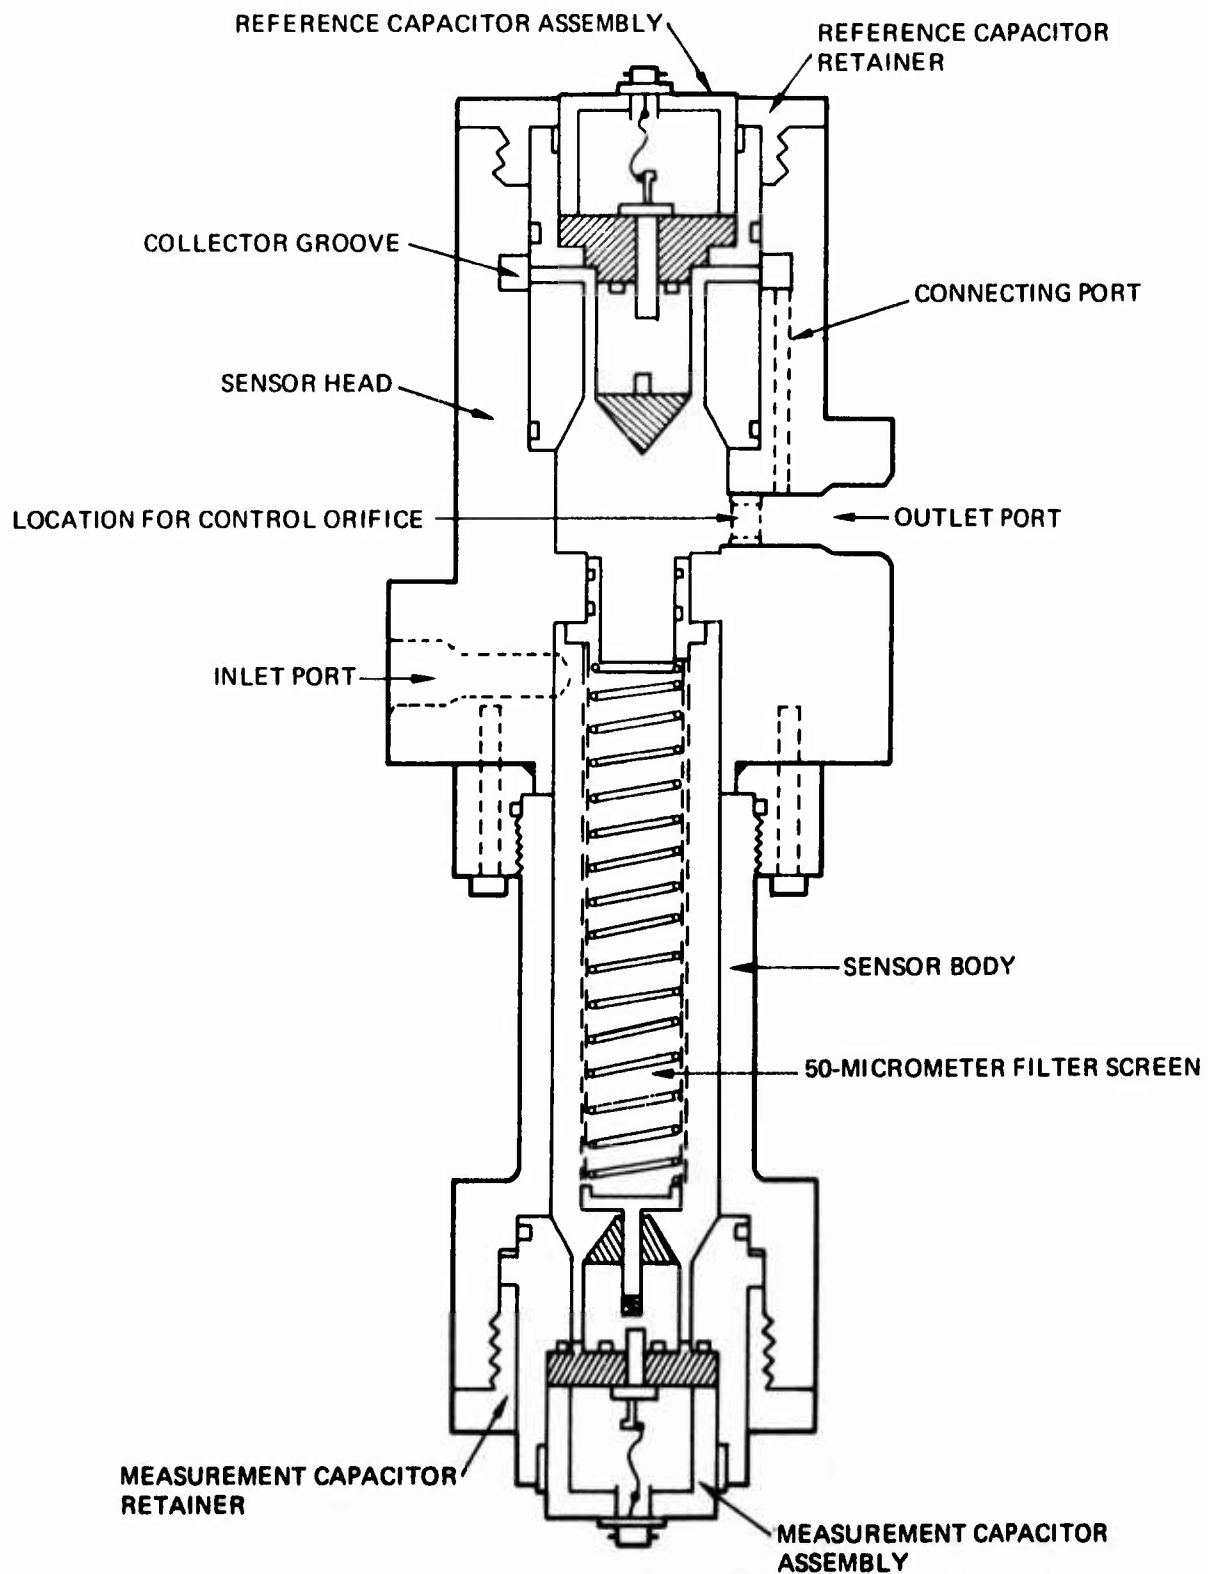
Figure 6 shows a cross-sectional view of the sensor assembly. The electrical signals generated by the bridge circuit were monitored and periodically sampled by the computer. Figure 7 is a picture of the capacitance type sensor head and electronic controller.

Figure 6. Capacitance Type ODM Sensor Assembly.

The "Advanced Capacitative Oil Debris Monitor" was developed by the Franklin Institute Research Laboratories under an Army contract.¹ This concept is based on collecting particulate debris in an annular space between the plates of a cylindrical capacitor. Debris is removed from the oil stream by centrifugal action caused by tangential introduction of the oil flow into the monitor cell, and by passing the flow through a 50-micrometer screen which is continually washed by the fluid flow. The particulate material settles into the measuring capacitor. The fluid which passes through the screen is allowed to flow through a reference capacitor with the same dimensions as the measuring capacitor. The measuring capacitor and the reference capacitor are compared by a bridge circuit so that the undesired capacitance effects due to changes in oil properties (temperature, water content, and dielectric constant) can be cancelled. Measured capacitance differences at the output of the bridge should therefore be due only to metallic debris buildup on the measurement capacitor.

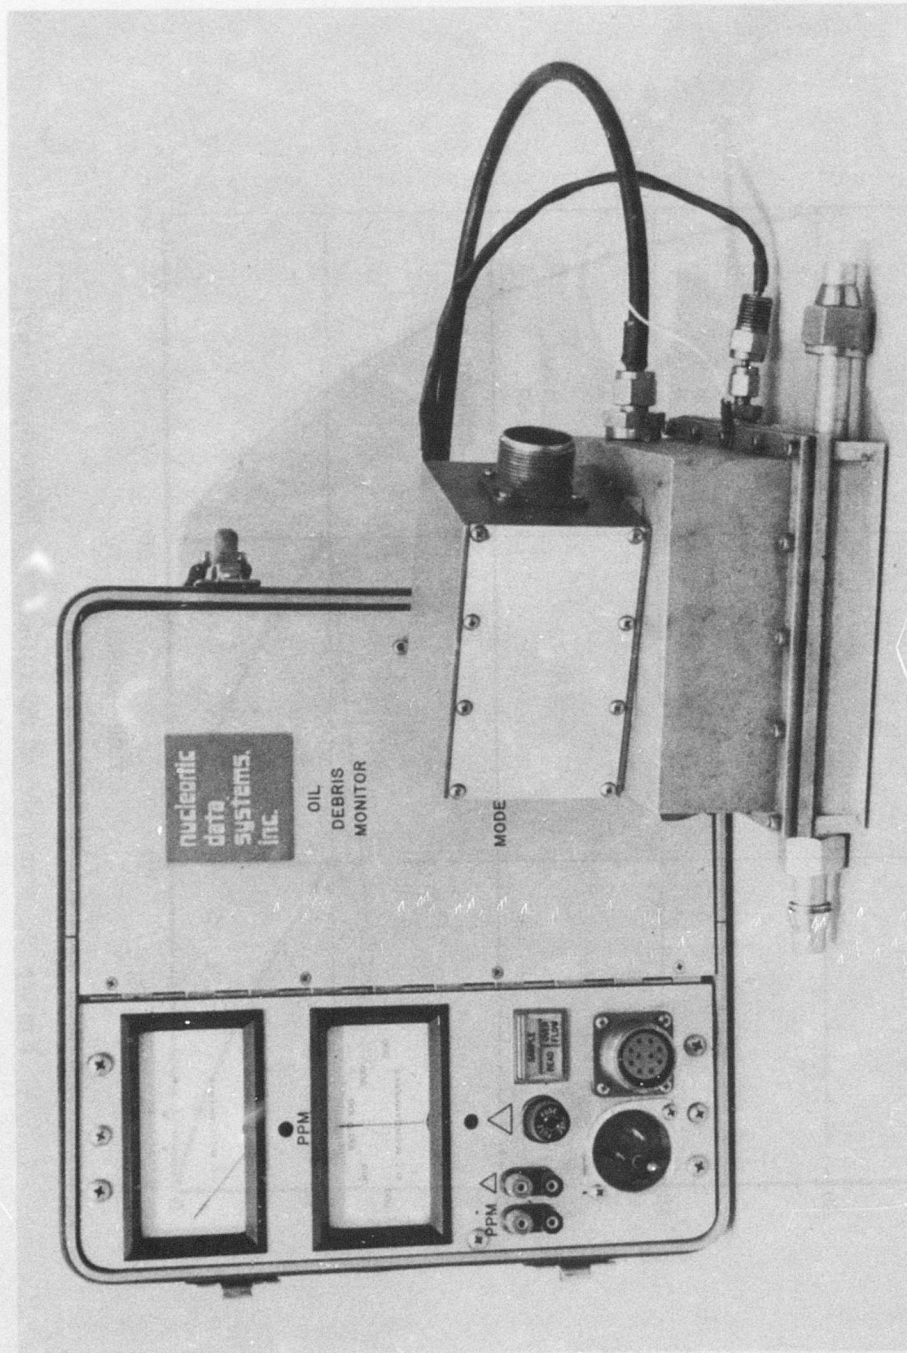
As shown in Figure 8, this device also consists of a sensor head and an electronics package. Oil flows through the sensor head, which contains a sealed source of 10 millicuries of plutonium 238. The plutonium is sealed in a stainless steel capsule with a 5-mil molybdenum window. Beta rays from the plutonium source are used to excite the molybdenum window to produce 17 KV X-rays. These X-rays stimulate the emission of 6.4 KV X-rays from iron particles in the oil. These 6.4 KV X-rays are sensed by a detector located within the sensor head. The output signal is sent to the electronics package for further processing. In addition to the plutonium 238 source, 0.03 millicurie of americium 241 is electrodeposited as americium oxide on a stainless steel support. The americium 241 provides a 60 KV gamma ray source for internal calibration of the sensor. Both sources are contained inside a 1/2-inch-thick aluminum box, which constitutes the sensor head.

Figure 8. X-ray Fluorescence Type ODM, Electronics and Sensor Head.

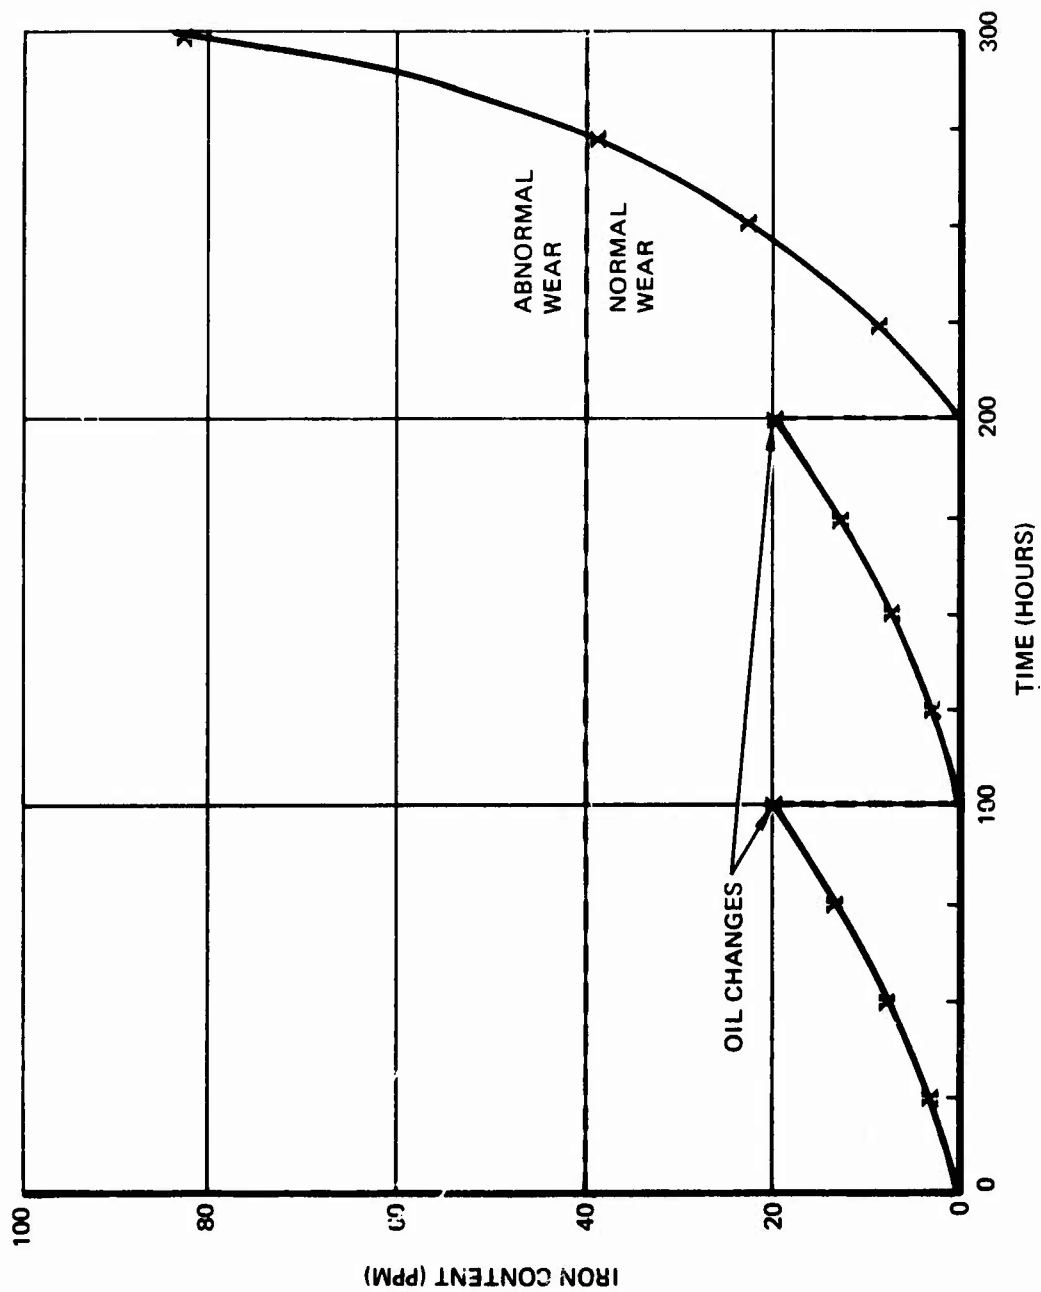
Figure 9. Example of SOA Data for Defective Gear.
X = Oil Sample.

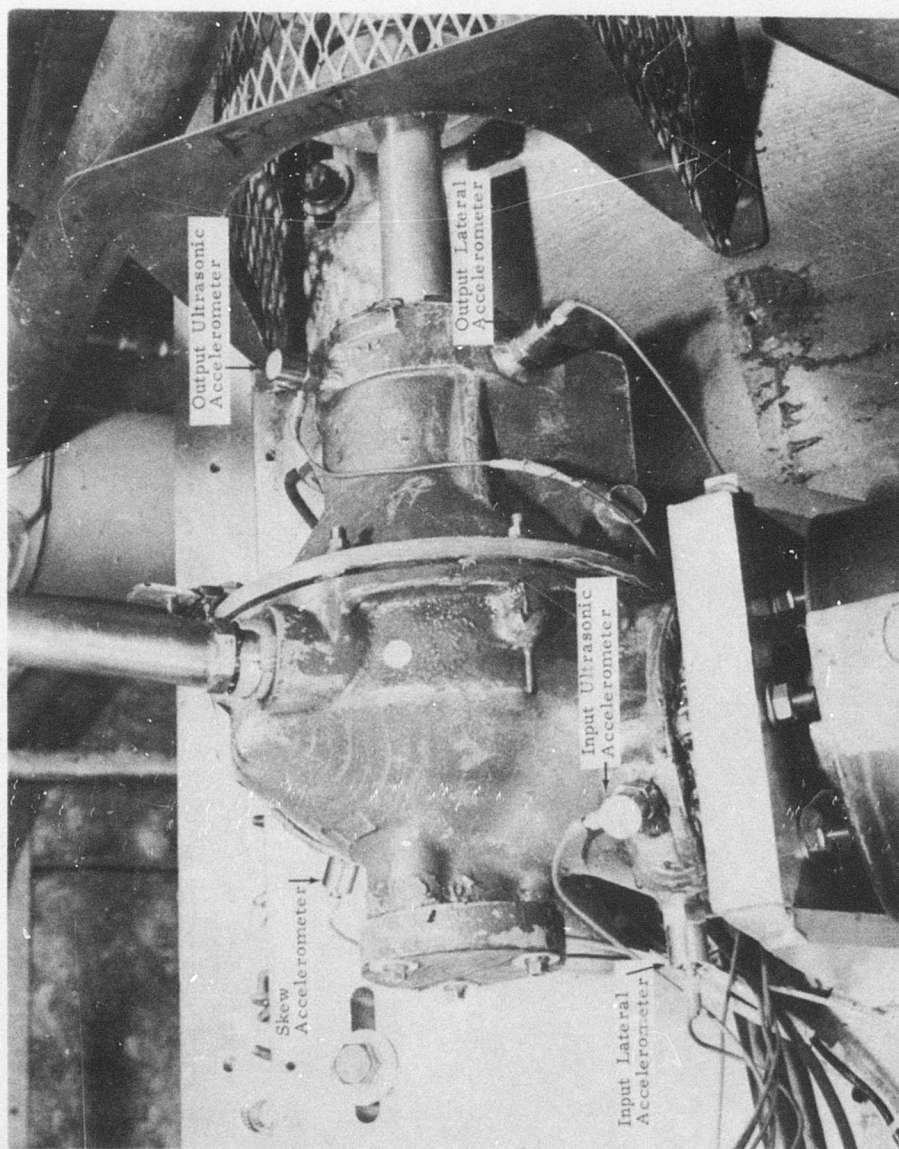
Figure 10. Accelerometer Locations.

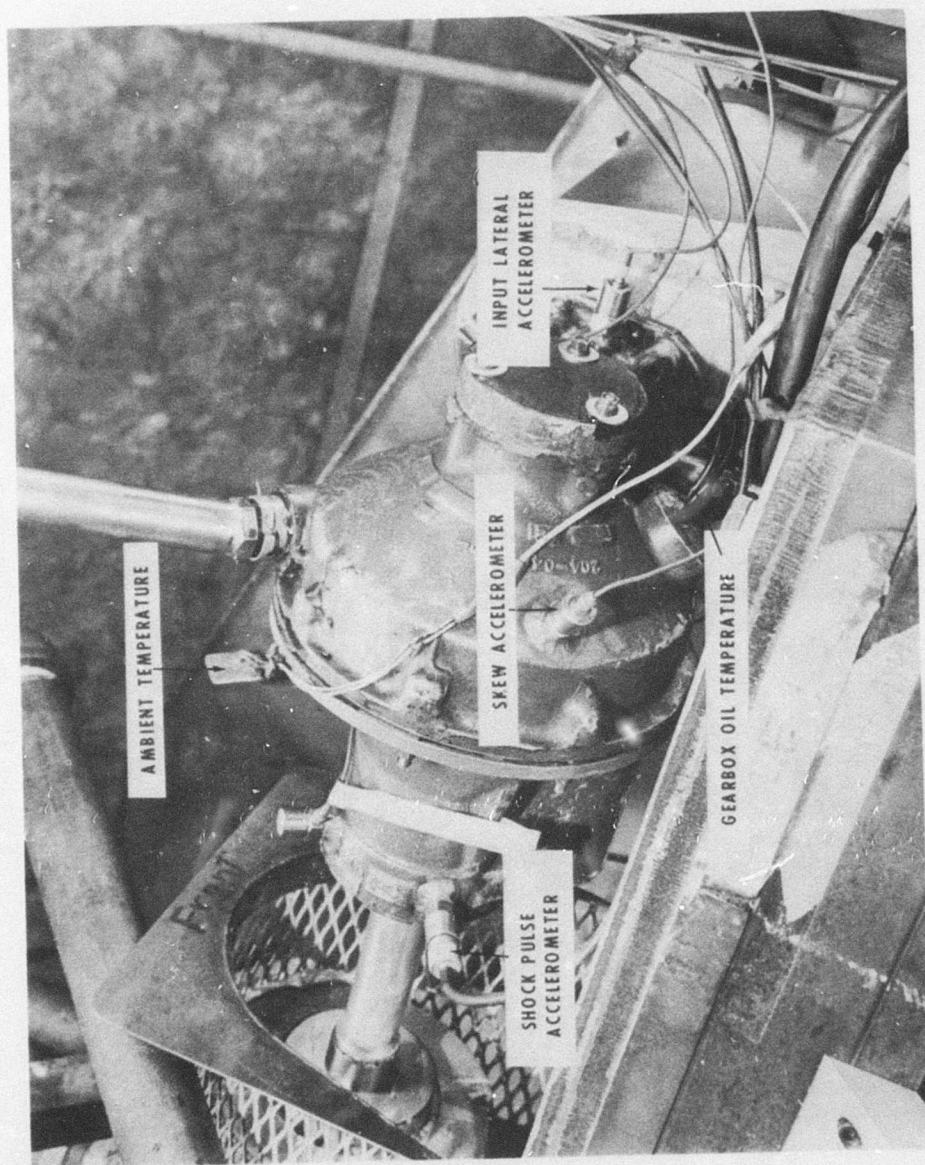
Figure 11. Accelerometer Locations.

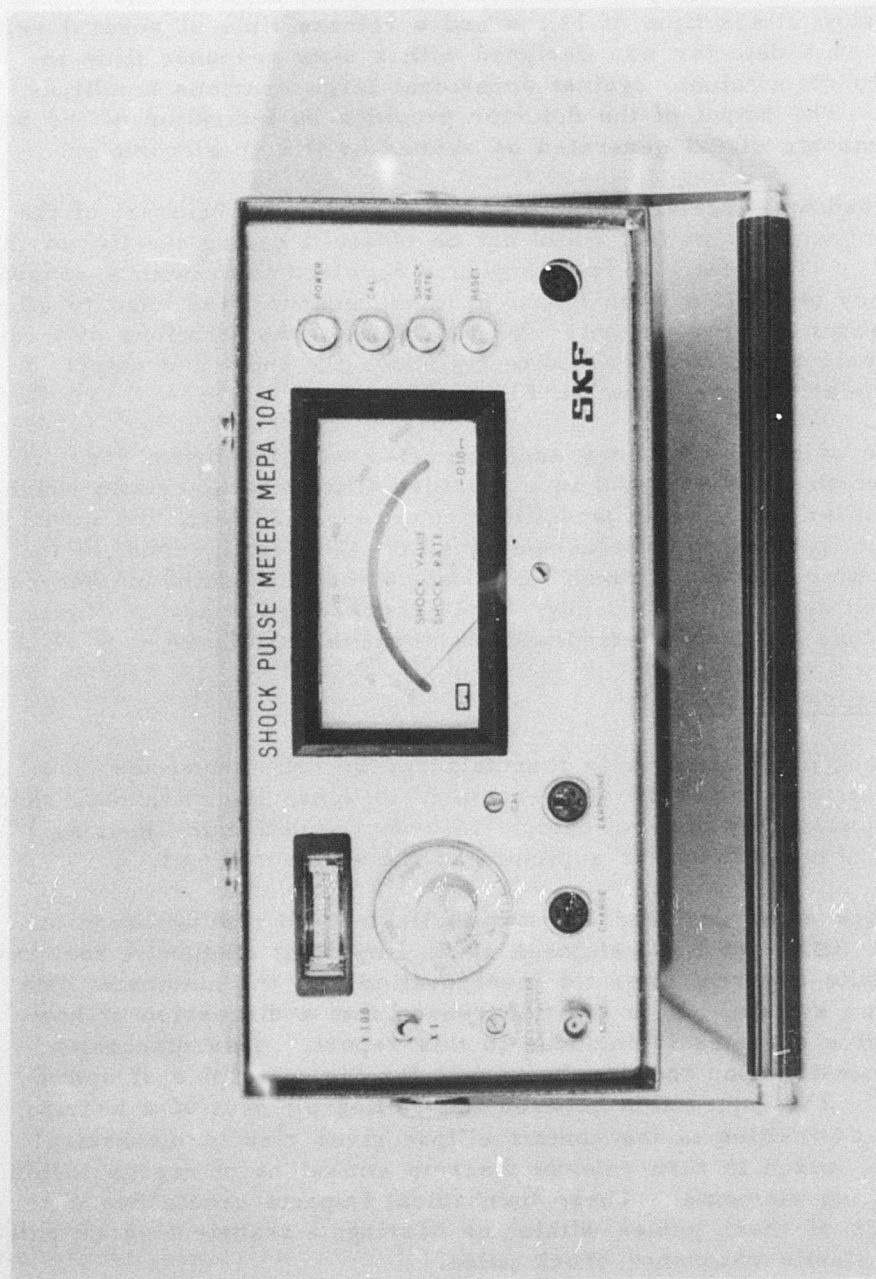
The shock pulse monitor is manufactured by SKF Industries, Inc. This instrument uses an accelerometer to sense the ultrasonic shock pulses emitted by bearing defects in order to determine bearing health. Figure 13 shows a picture of the electronic unit.

Figure 13. SKF Shock Pulse Analyzer.

The shock pulse analyzer was not available until testing began on gearbox BBT, but its usefulness as an important diagnostic tool became quite apparent after its incorporation into the automatic data collection system. It is for this reason that a discussion of how this device operates is included in this report. This discussion relies heavily upon the user's manual for the principles of operation.^{3,4} The interaction between the rolling element of a bearing and discontinuities in the contact ellipse gives rise to mechanical impacts, which in turn release discrete emissions of energy within the bearing elements. These mechanical impacts create two different kinds of shock pulses within the bearing: a transient shock pulse and an elastic resonance shock pulse.

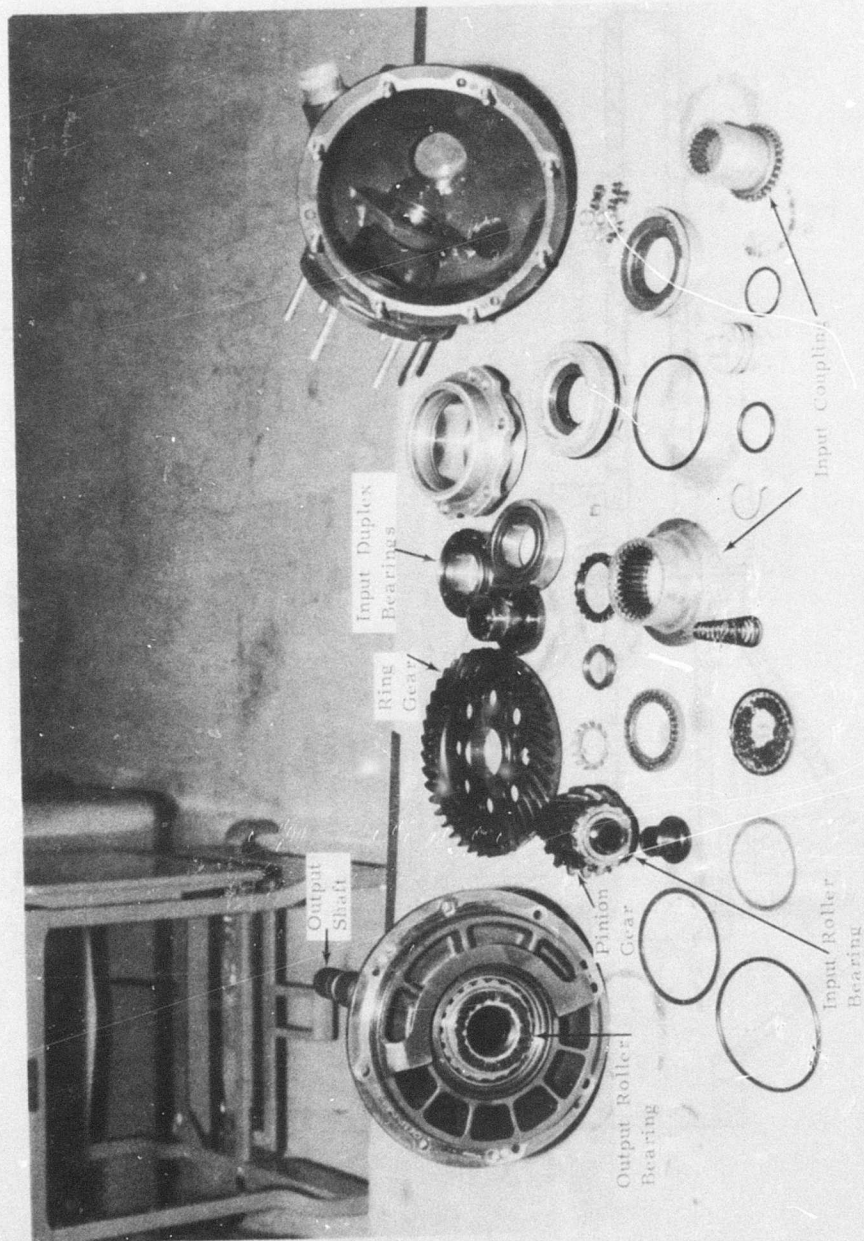
Figure 16. Partial Disassembly of a 90° Gearbox.

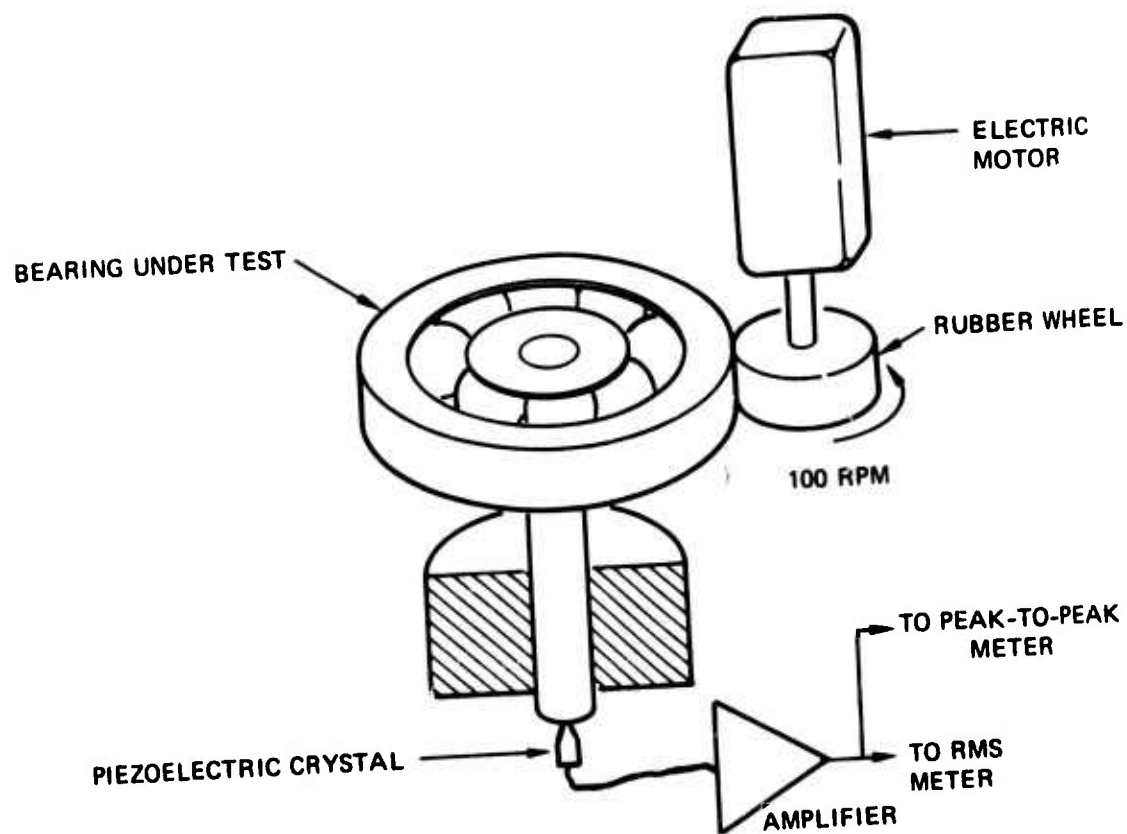
Figure 17. Schematic Diagram of Dynamic Noise Test.

Another parameter derived from the noise test is the relationship between the peak-to-peak vibration noise level and the RMS

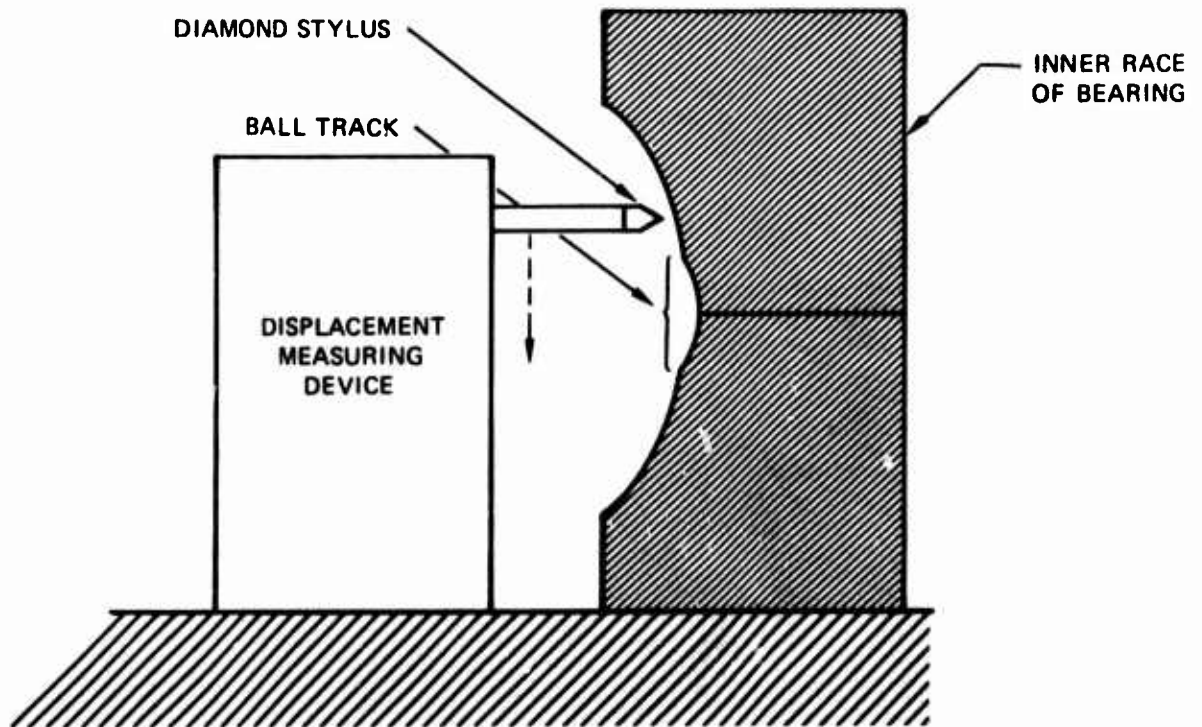
Figure 18. Schematic Diagram of Cross-Groove Profile Measurement.

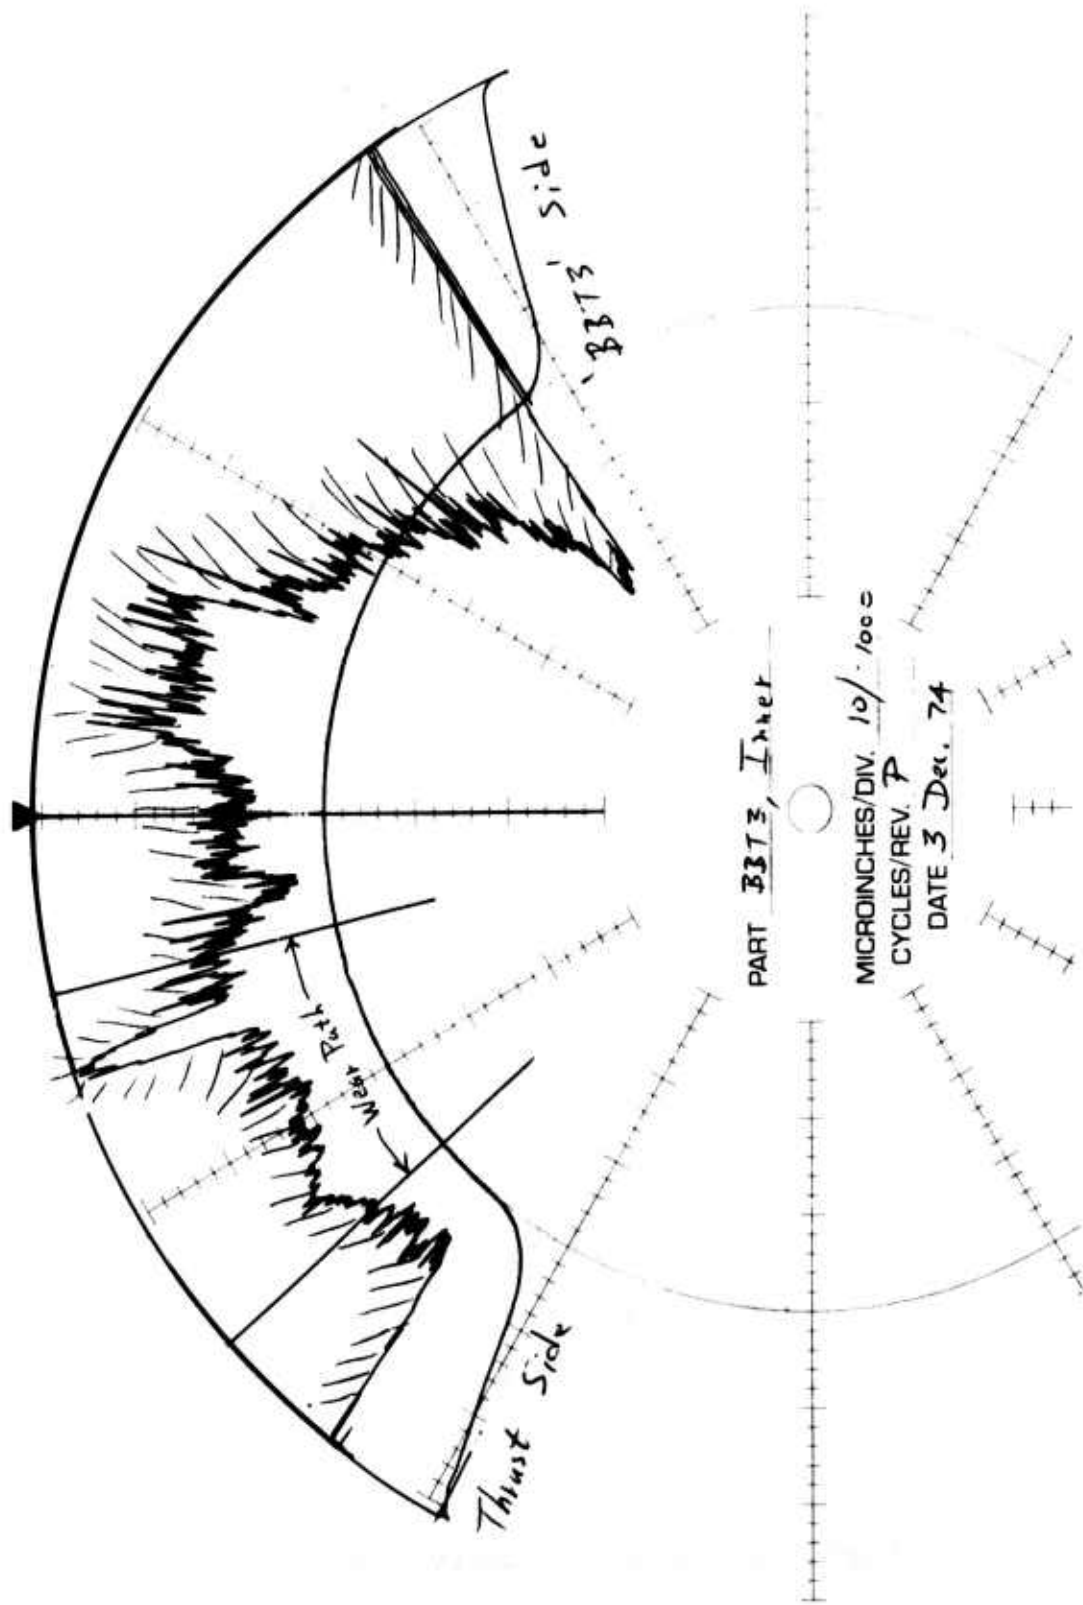
Figure 20. BBT-3 Cross-Groove Profile at 1022 Test Hours.

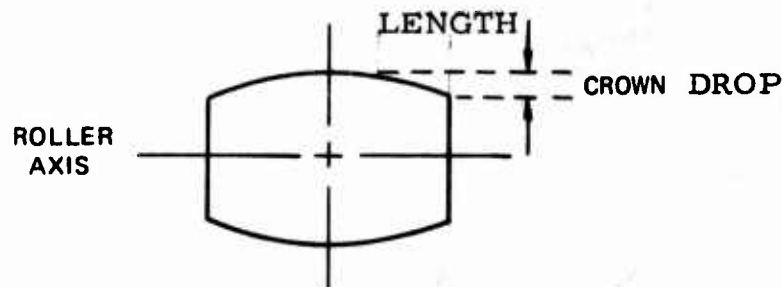
A new roller is designed to be slightly tapered on the ends, as shown in Figure 21. This taper, called a crown, serves to relieve stress concentration from the ends of the roller during normal load conditions. As the roller wears, the crown becomes smaller. Crown wear measurements are sensitive measures of actual roller wear.

Figure 21. Roller Crown Parameters.

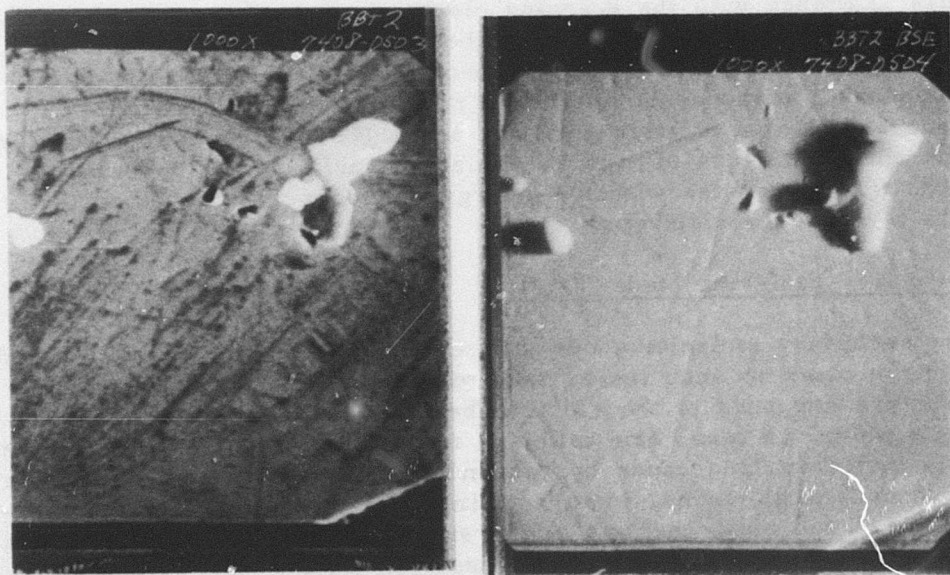
Figure 22. SEM Micrographs of BBT-2 (407 Hours).

The backscatter emission mode utilizes a high-energy (10 kev) focused electron beam to scan the specimen. The high-energy electrons

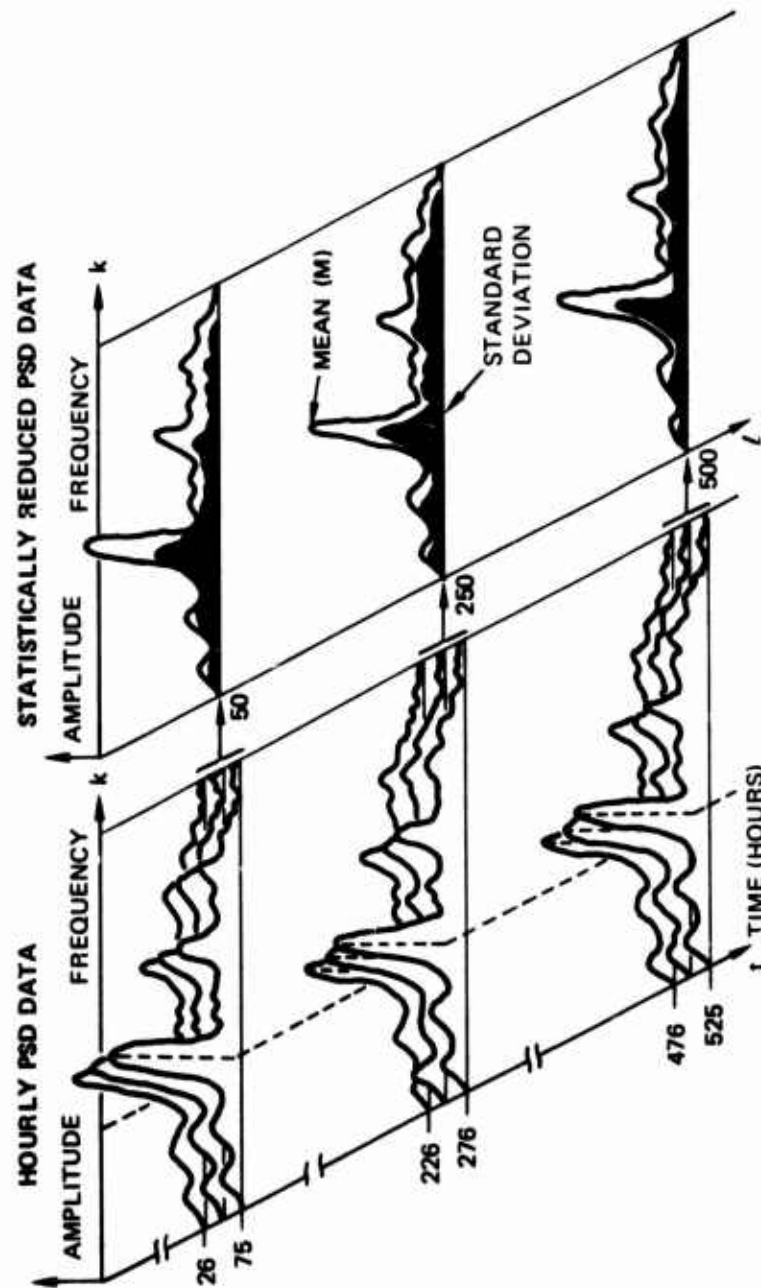
Figure 31. Structure of PSD Mean - Standard Deviation Data Base.

The second phase of the statistical analysis involved the determination of statistically significant differences between the mean and standard deviation of the reference group (25-hour point) and each subsequent 50-hour group. The methods of statistical decision theory were applied to the mean and standard deviation statistics to identify those differences which might indicate that the mechanical condition of the gearbox is changing.

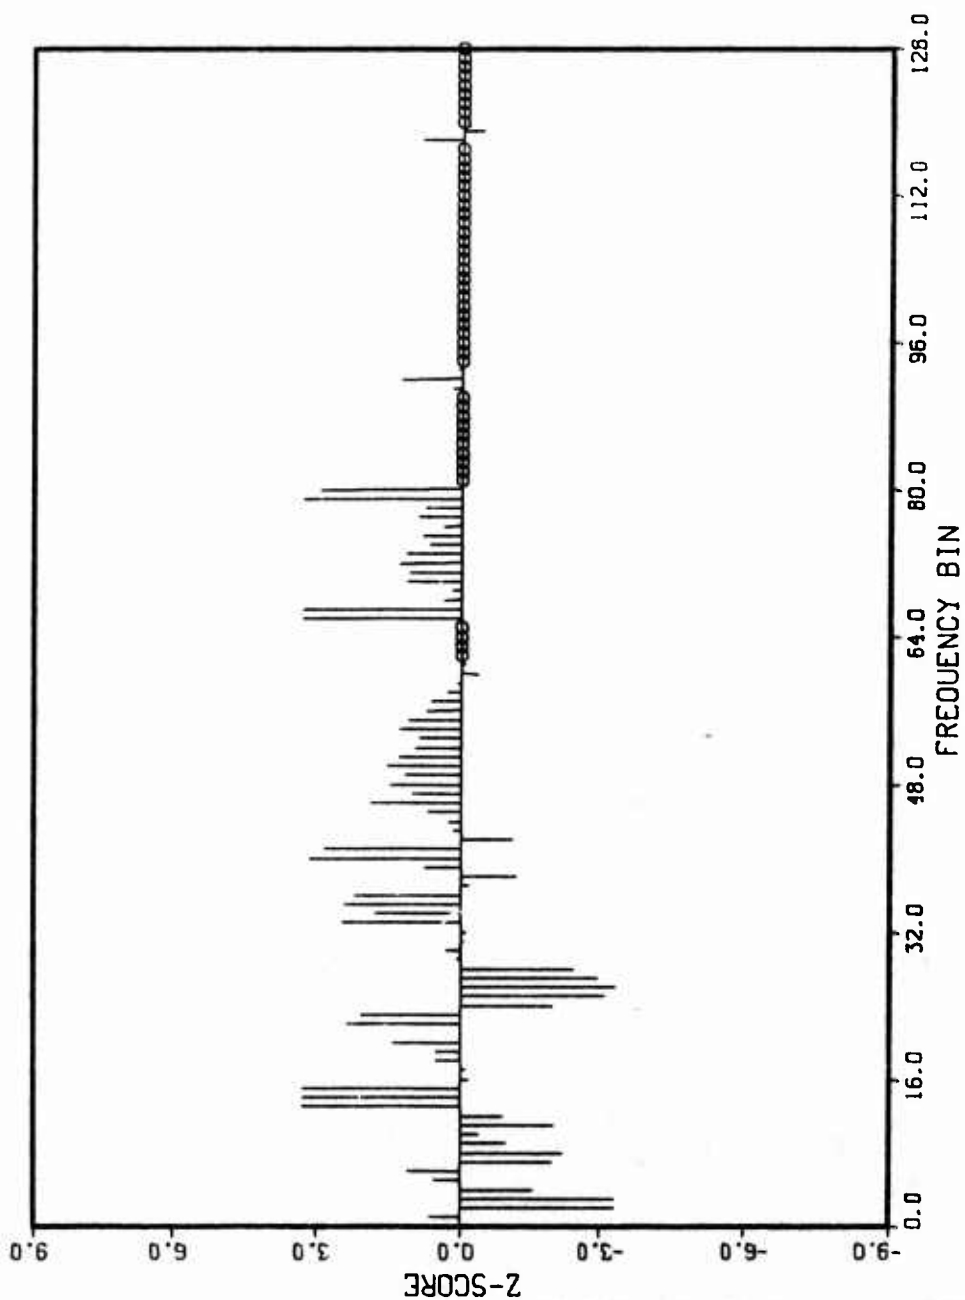
Once we have identified the frequency bins in the PSD data that meet the Z-score criteria for change, we use these frequencies from each hourly ensembled PSD for our trend analysis. The objective of conducting a trend analysis on the vibration data is to determine in a quantitative manner the time history of the data in each frequency bin over the test period of the gearbox. It is hoped that trends found in this data can be correlated with gearbox wear as determined by other sensors or post-test wear measurements. Since an enormous amount of data was collected in this program, we selected data from ensembled PSD's taken every 5 to 10 hours for use in the trend analysis. After the frequency bins of interest were determined and the data in these bins plotted with time, second- and third-degree polynomial curves were fitted to the data on a minimum mean-square error

Figure 32. Typical Z-Score Linear Discriminant Plot.

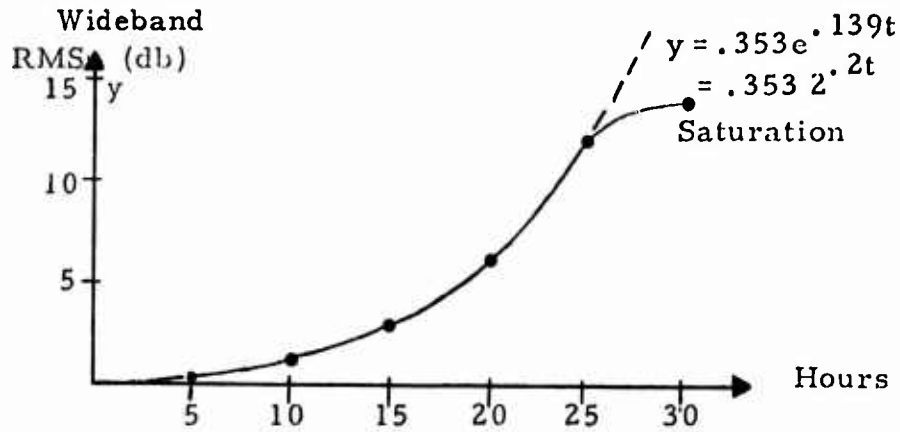
Figure 33. Wideband (100 Hz to 5 kHz) RMS Vibration Level of Input Longitudinal Accelerometer (UH-1 Helicopter Transmission).

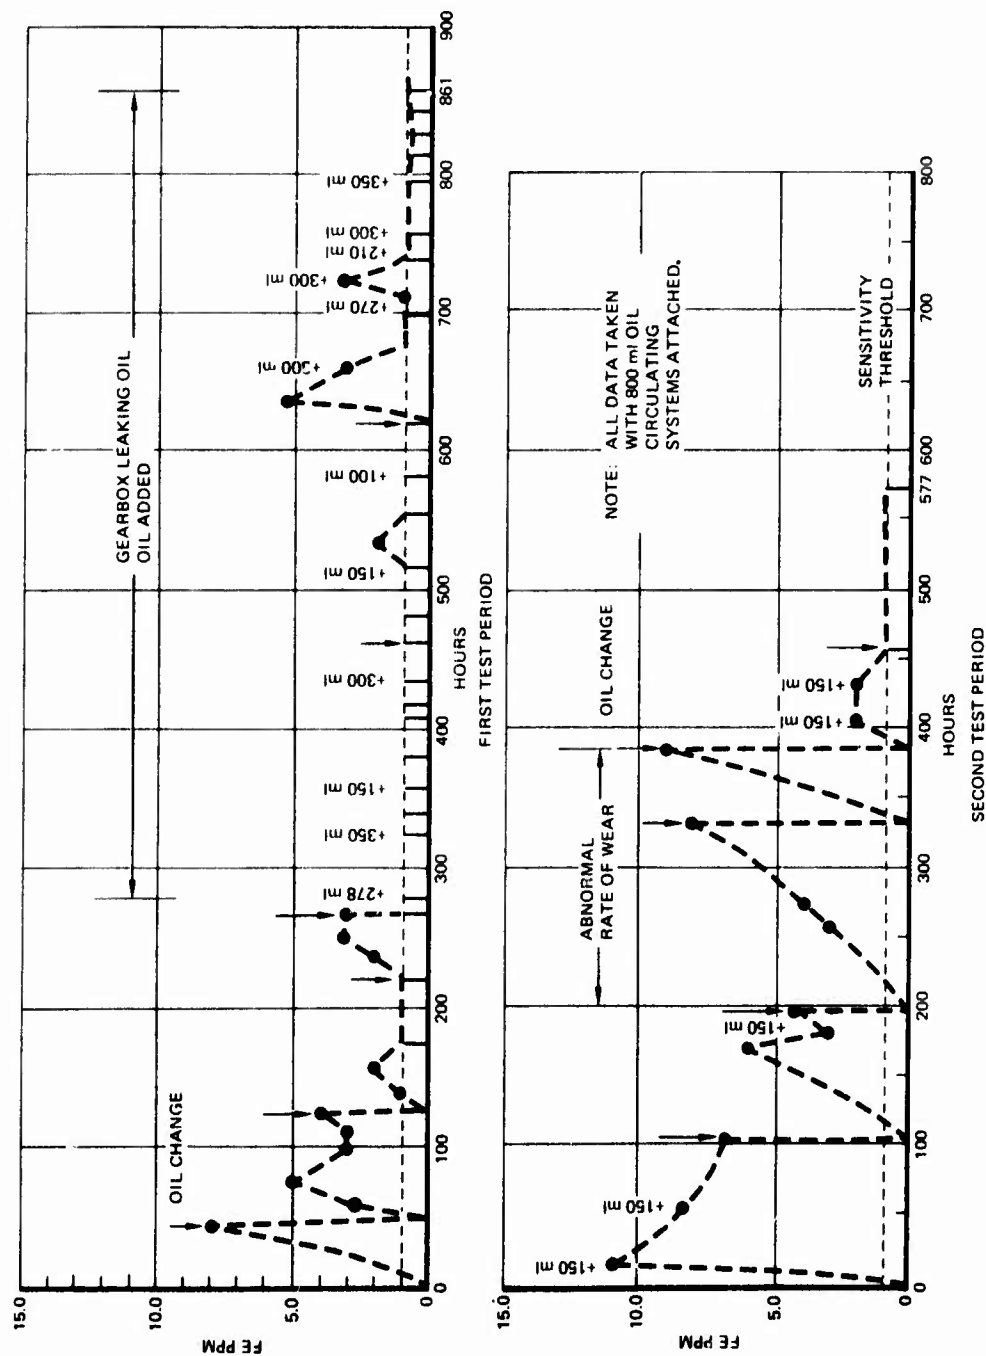
Figure 40. Summary of HT Gearbox SOA.

At the end of the first test interval (861 hours), another gearbox inspection was performed. Visual inspection of the ball and roller bearings showed increased wear in the output duplex ball bearing and a significant deterioration in the condition of the input roller bearing. Noise testing of the ball bearings shows moderate wear with light local damage.

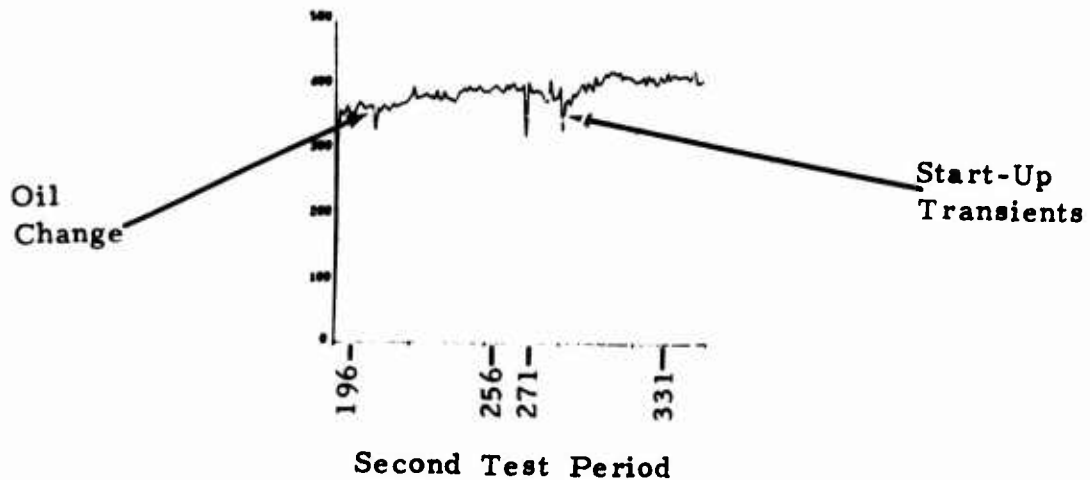
Figure 43. Typical HT Gearbox Peak Shock Pulse Level Data.

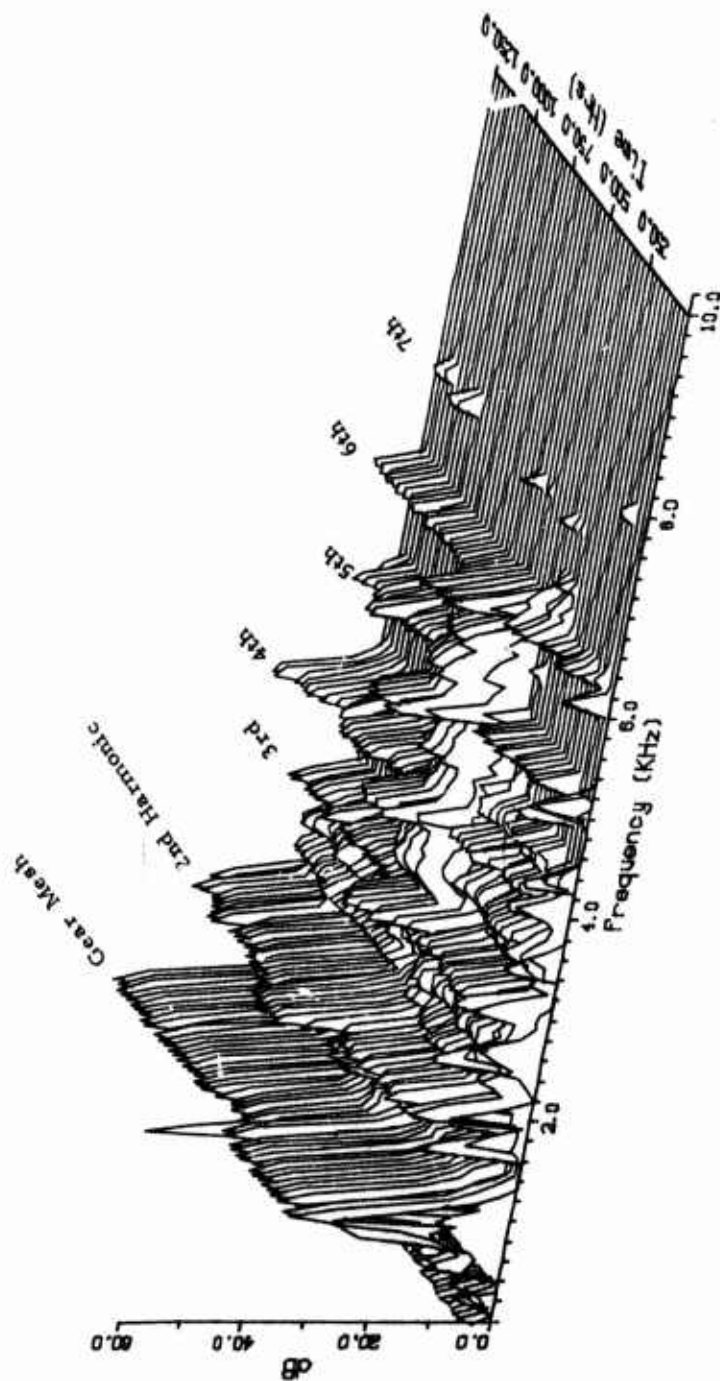
Figure 44. Overall View of H₁ Vibration Data Base,
Input Lateral Accelerometer.

This type of plot enables the analyst to quickly determine the vibration frequencies which are characteristic of the operation of the particular gearbox under test and its mechanical condition. It also provides a rapid method for detecting changes in the operational

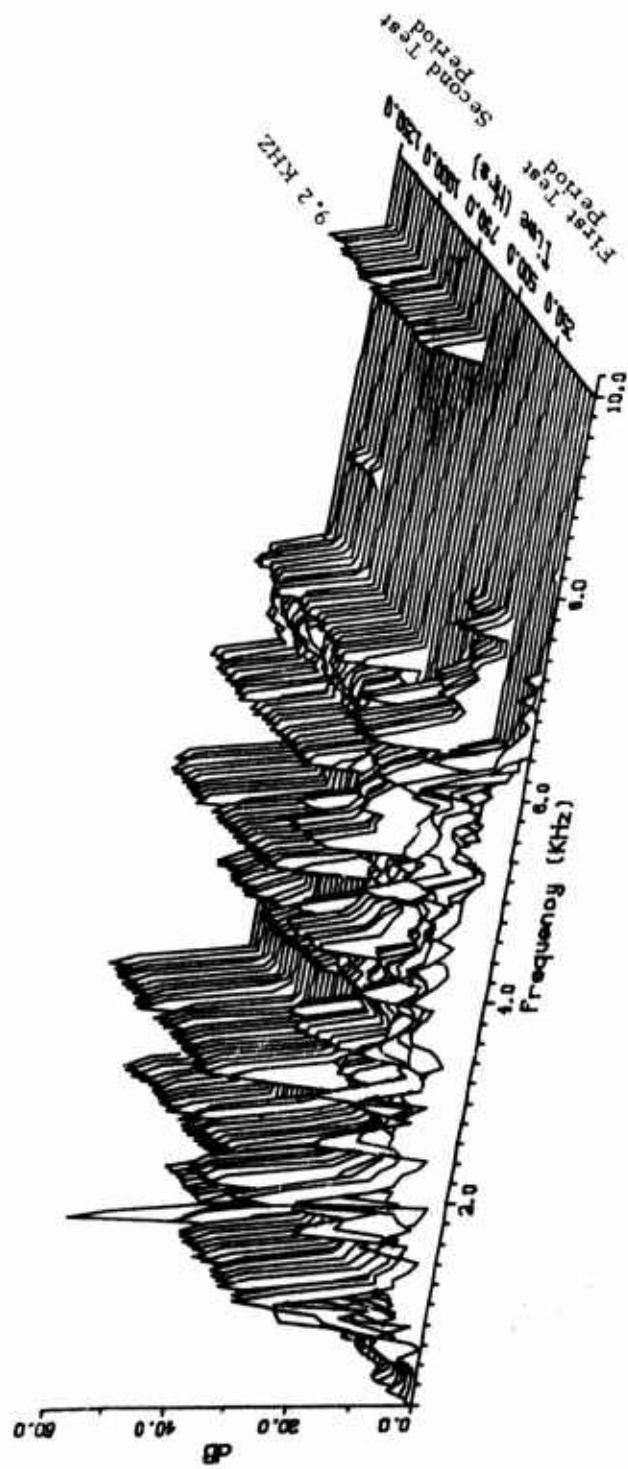
Figure 46. Overall View of HT Vibration Data Base,
Output Lateral Accelerometer.

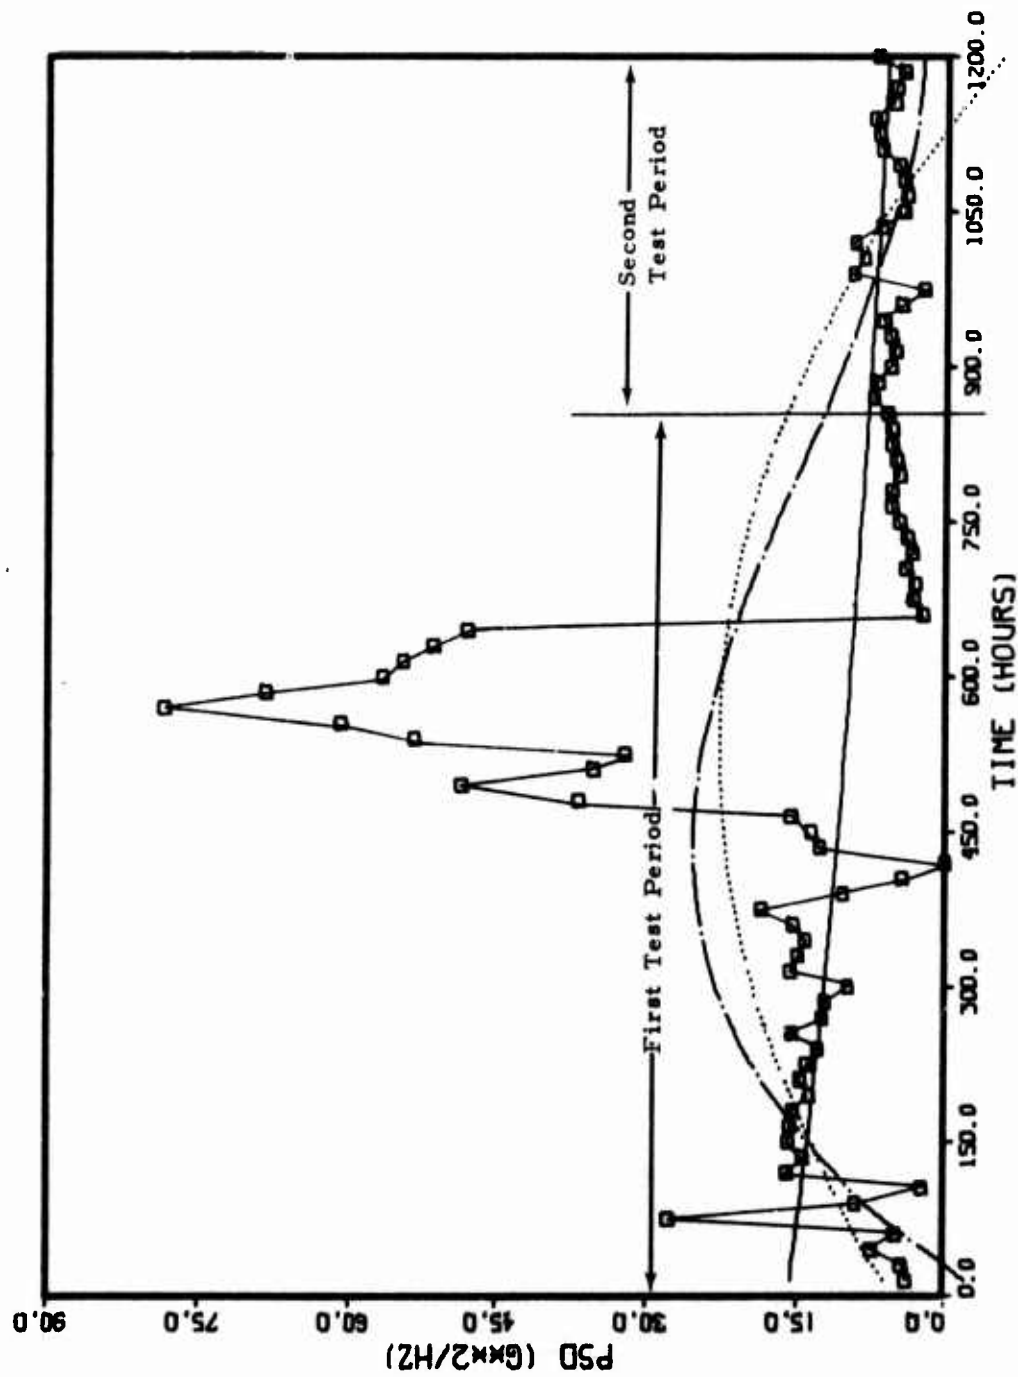
The vibration data from the HT gearbox was characterized by many abrupt changes in amplitude at certain frequency bins. These are considered to be abnormal and could have been caused by instrumentation problems experienced early in the testing program. For this

Figure 47. PSD Vibration Path, HT Vibration Data, Input Lateral Accelerometer, 3202 Hz.
